## **Partially Welded Contacts and Effects on Auxiliary Contacts**

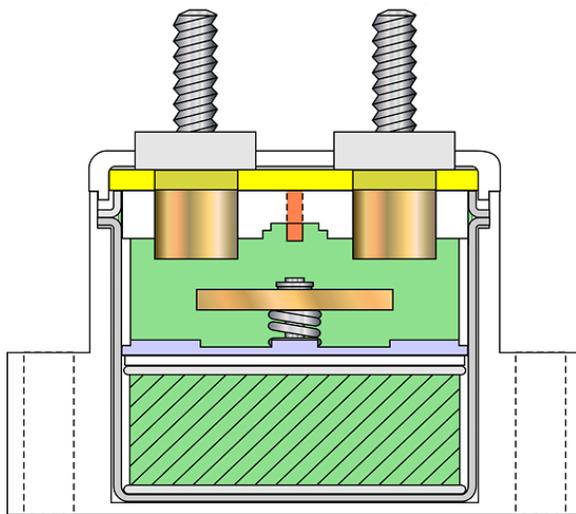
**Open Contacts**

In most cases, welded contacts result in continuity across the main contacts because the contacts do not open. A partial weld results in one side of the main contacts opening, while the other side remains closed (illustrated below):

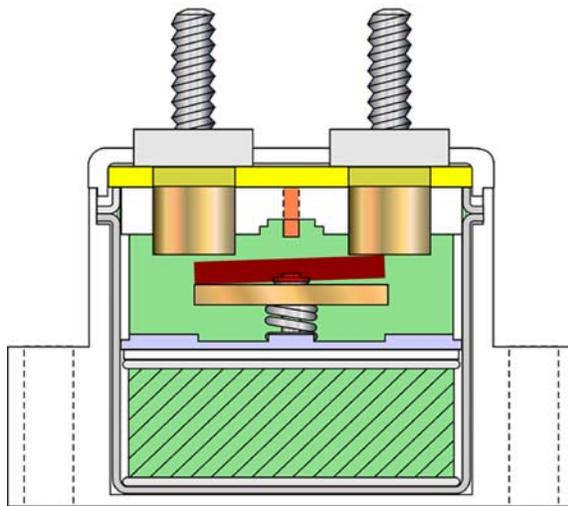
**Partial Weld**

(auxiliary contacts remain closed)

The contactor on the right shows a partial weld. Instead of the contacts opening fully, they open only slightly on one side (as indicated by the red bar).

The auxiliary contacts on the GIGAVAC contactors are designed to always stay closed in this case (assuming Normally Open auxiliary contacts). **The auxiliary contacts will only open if the contacts fully open on both sides. This is done for safety reason and is an intended function of the relay.**

**As a result, this fault condition (closed auxiliary contacts, open main contacts) is always the result of welded main contacts.** GIGAVAC is not aware of any cases in which auxiliary contacts were actually welded when used within operating parameters. Every instance where the auxiliary contacts indicated closed, the main contacts showed signs of being welded.

Since partial welds are relatively easy to break open, it is possible to actuate the coil 10-20 times with no load on the contacts. This process will usually return the contactor to a normal state of operation.

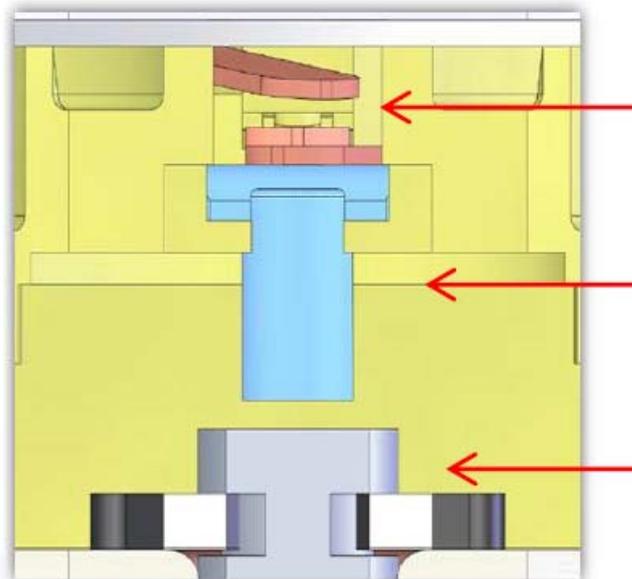
Note that the GIGAVAC design for the auxiliary contacts is linked to the main power contact plunger to ensure fail-safe operation:

Auxiliary contacts are mechanically linked to the main armature for fail-safe position

Auxiliary Contacts

Plunger

Main Contacts
